# TESTING OF POLYIMIDE SECOND-STAGE ROD SEALS FOR SINGLE-STATE APPLICATIONS IN ADVANCED AIRCRAFT HYDRAULIC SYSTEMS

by A. W. Waterman

May 1977

Boeing Commercial Airplane Company  
P.O. Box 3707  
Seattle, Washington 98124

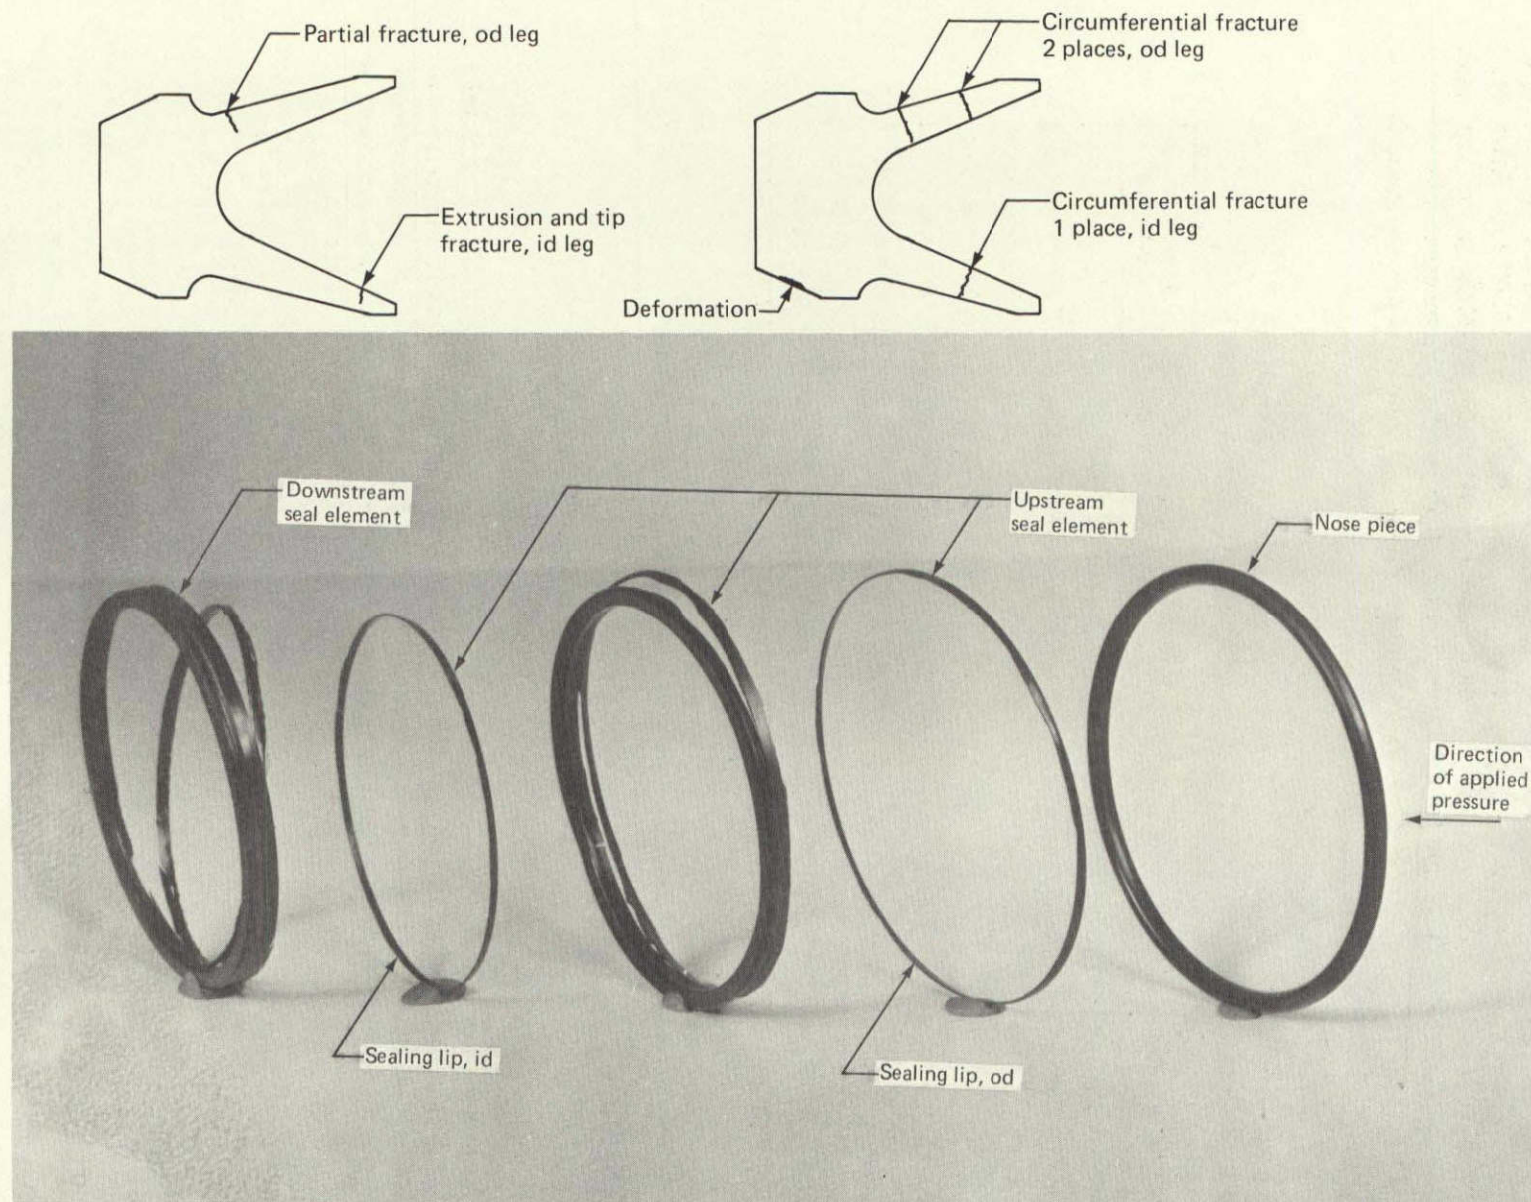
The test seal showed minimal-to-zero leakage while being subjected to successive 20 000-cycle segments at peak pressures less than 37.925 MPa (5500 psi). After 1120 cycles of the eighth and final segment, conducted at 37.925-MPa (5500-psi) peak impulse pressure, the seal showed considerable leakage. Seal inspection showed total structural failure of both K-section elements (figs. 2, 3, and 4). Leakage data for the screening test are shown in table 3.

Figure 2.—Test Seal Failure—Impulse Screening at 37.925 MPa (5500 psi)

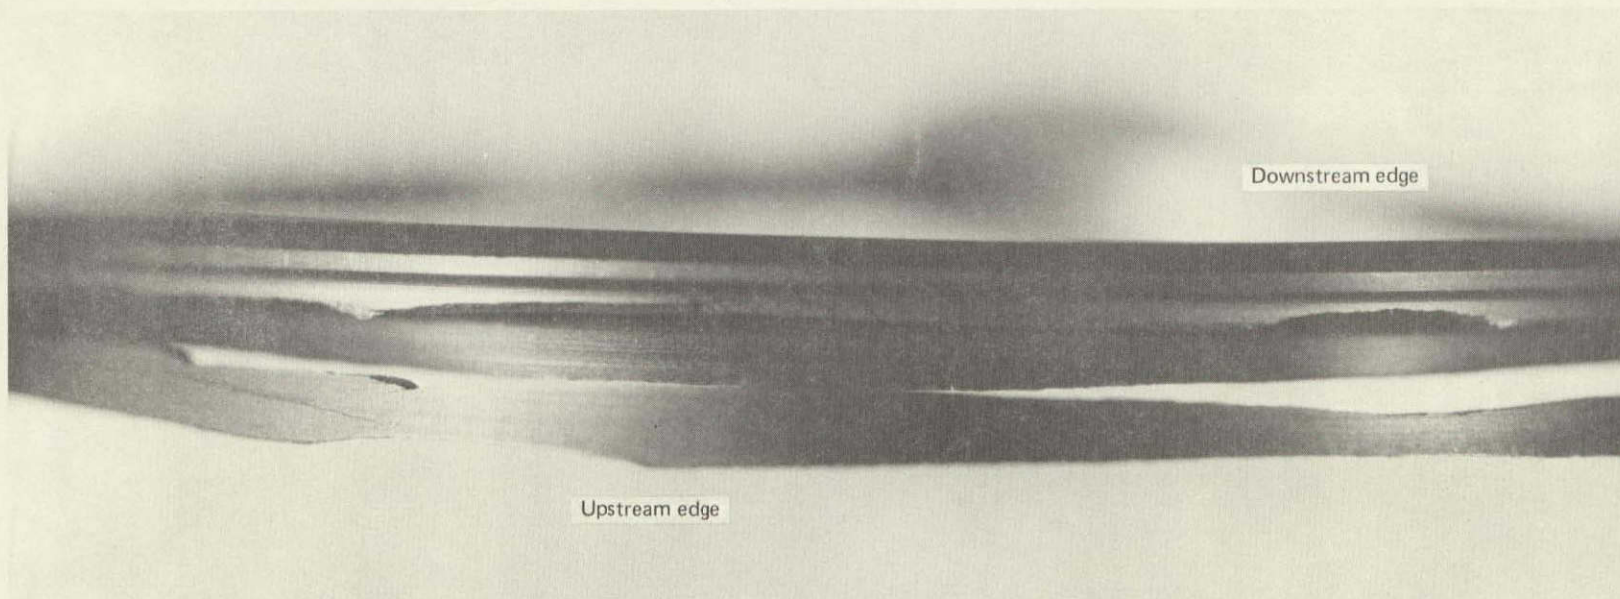
*Figure 3.—Impulse Screening Test Seal, Upstream Element—Failure at 37.925 MPa (5500 psi)*

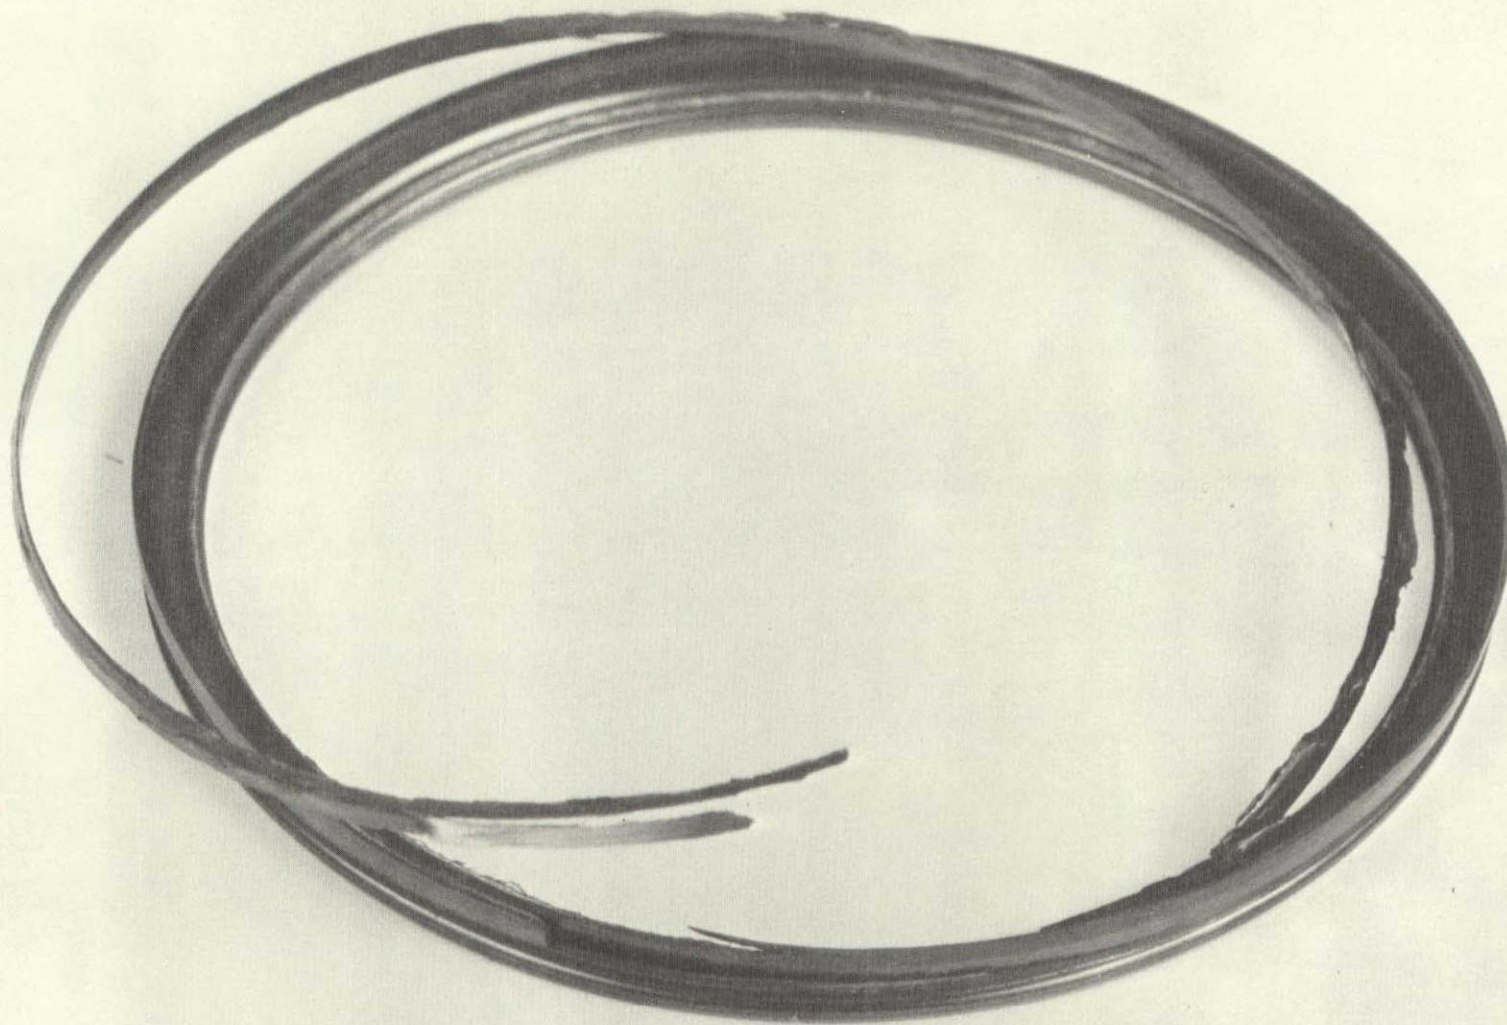
*Figure 4.—Impulse Screening Test Seal, Downstream Element—Failure at 37.925 MPa (5500 psi)*

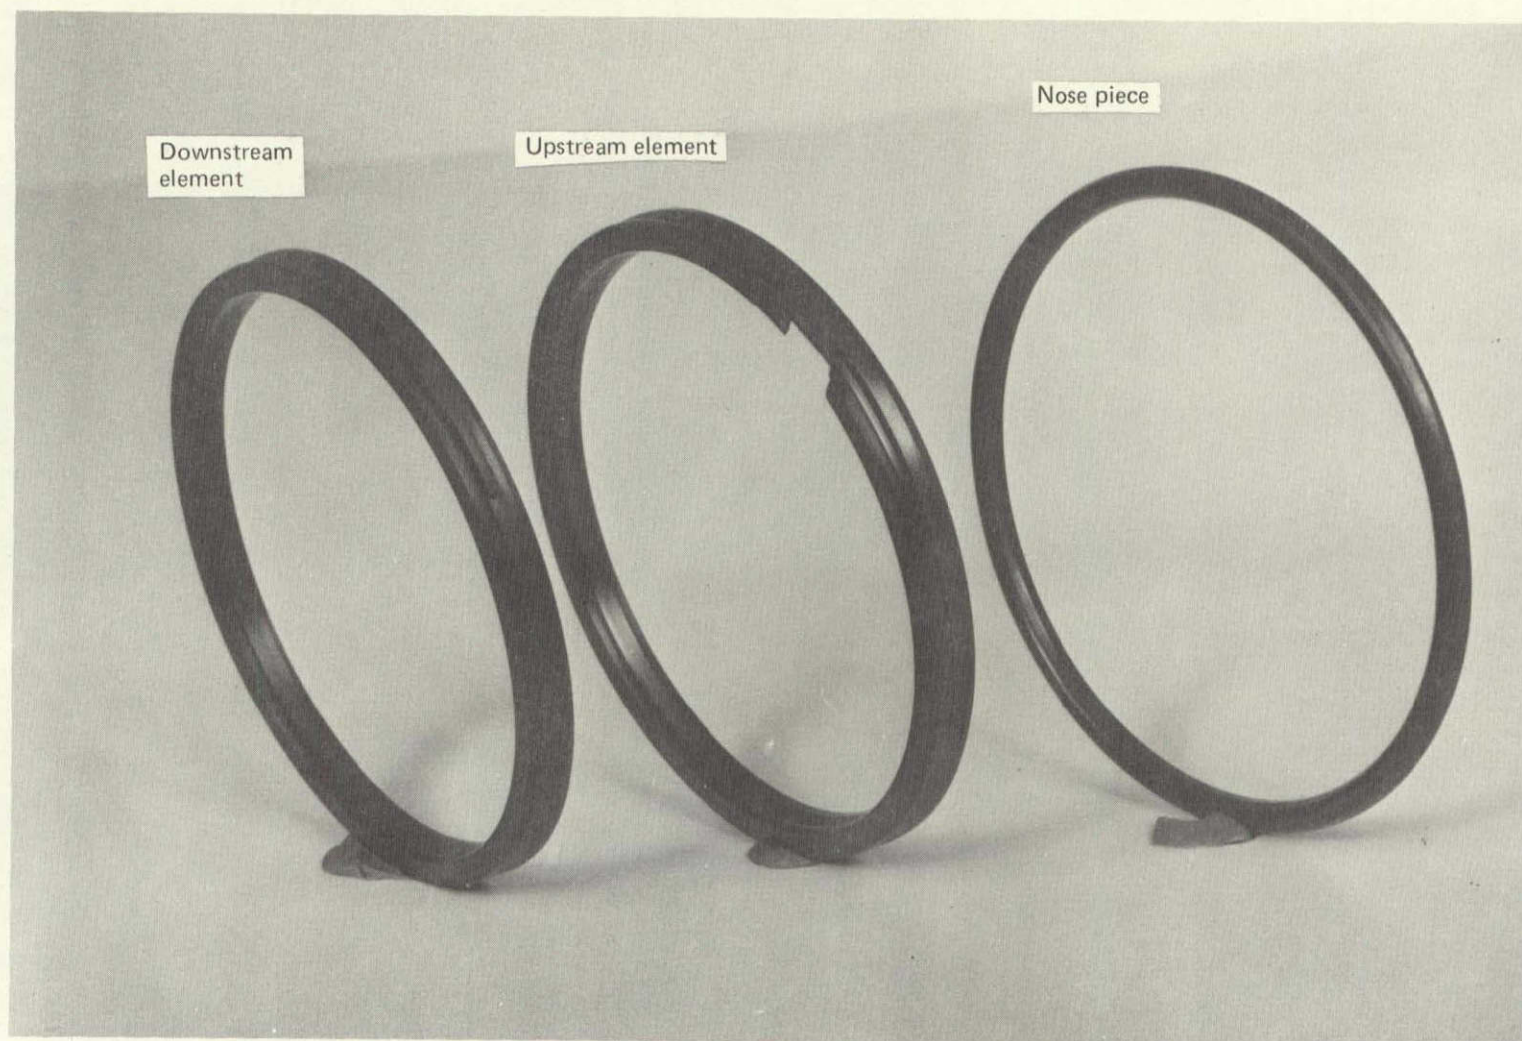
During the static pressure checkout of the seal assembly at 17.359 MPa (2500 psi) both elements 1 and 5 fractured. The apparent reason was installation damage resulting from a tight fit of element 5, used in the upstream position. Similar static pressurizations at 20.687 MPa (3000 psi) were conducted three times during the screening test without element failure. The failures of both upstream and downstream elements (figs. 5 through 7) show major localized fractures accompanied by circumferential cracks of the inside diameter (id) sealing legs. The major fractures in both elements occurred at the same circumferential location, indicating a secondary failure in the downstream element resulting from failure of the upstream element.

Figure 5.—Static Pressure Failure at 17.359 MPa (2500 psi)

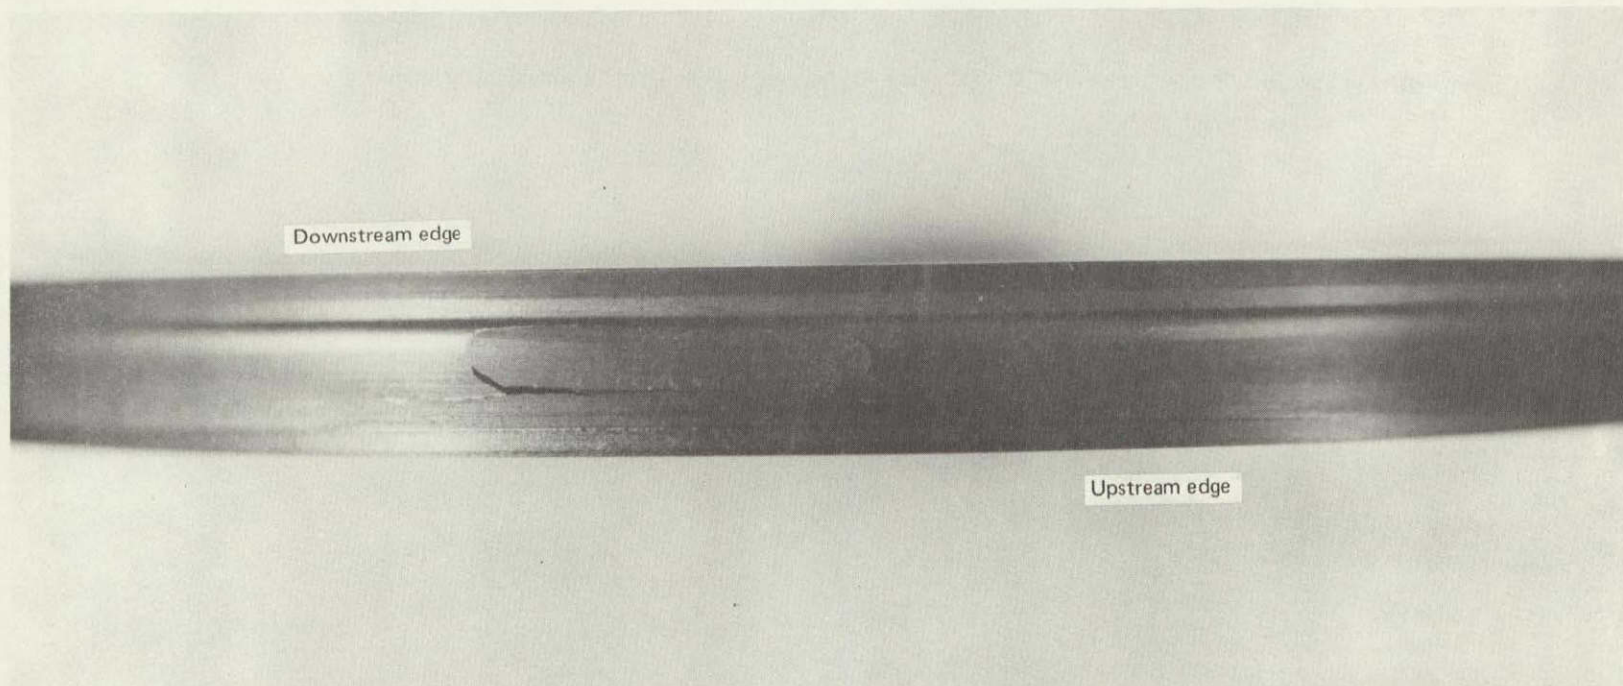
*Figure 6.—Static Pressure Failure at 17.359 MPa (2500 psi)—Downstream Element, Major Fracture*

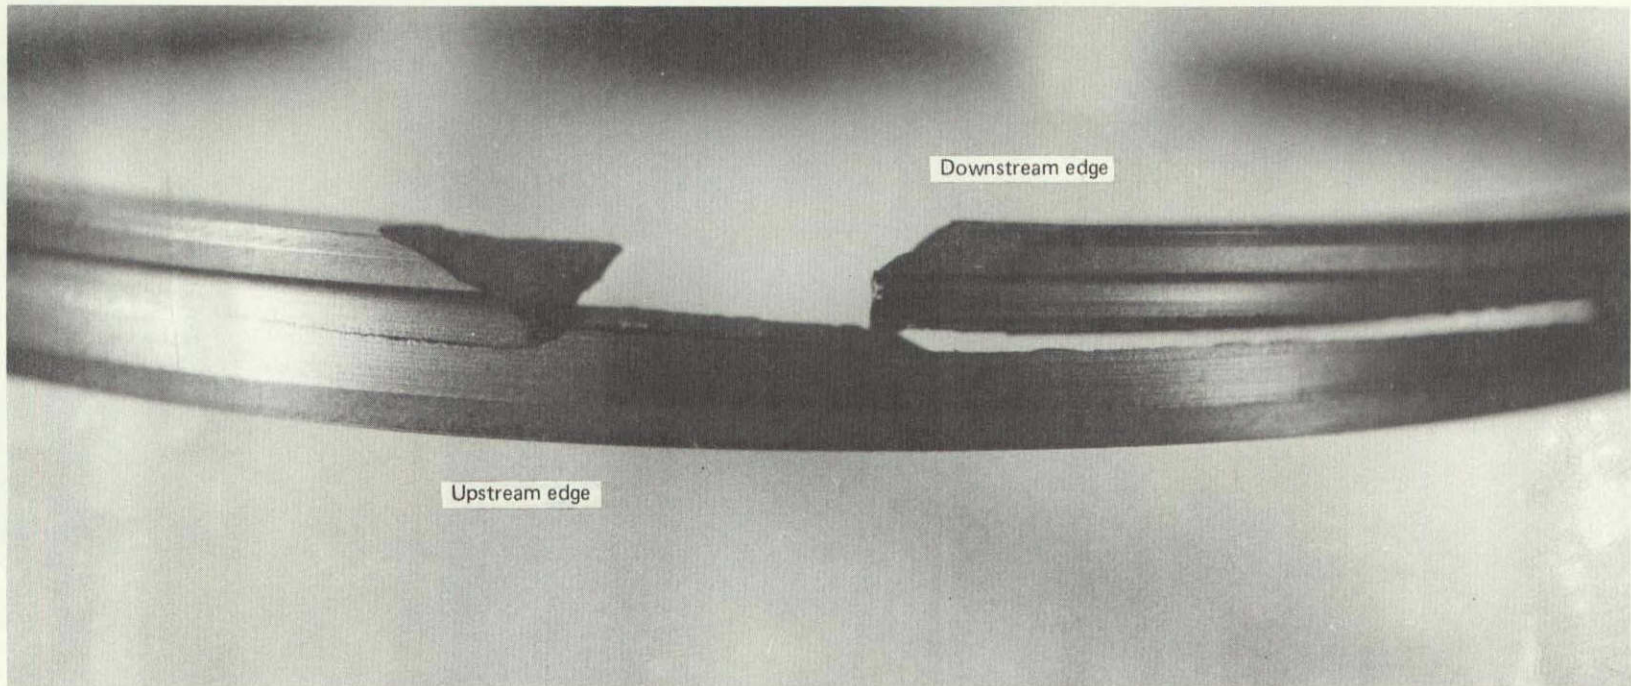
*Figure 7.—Static Pressure Failure at 17.359 MPa (2500 psi)—Upstream Element, Major Fracture*

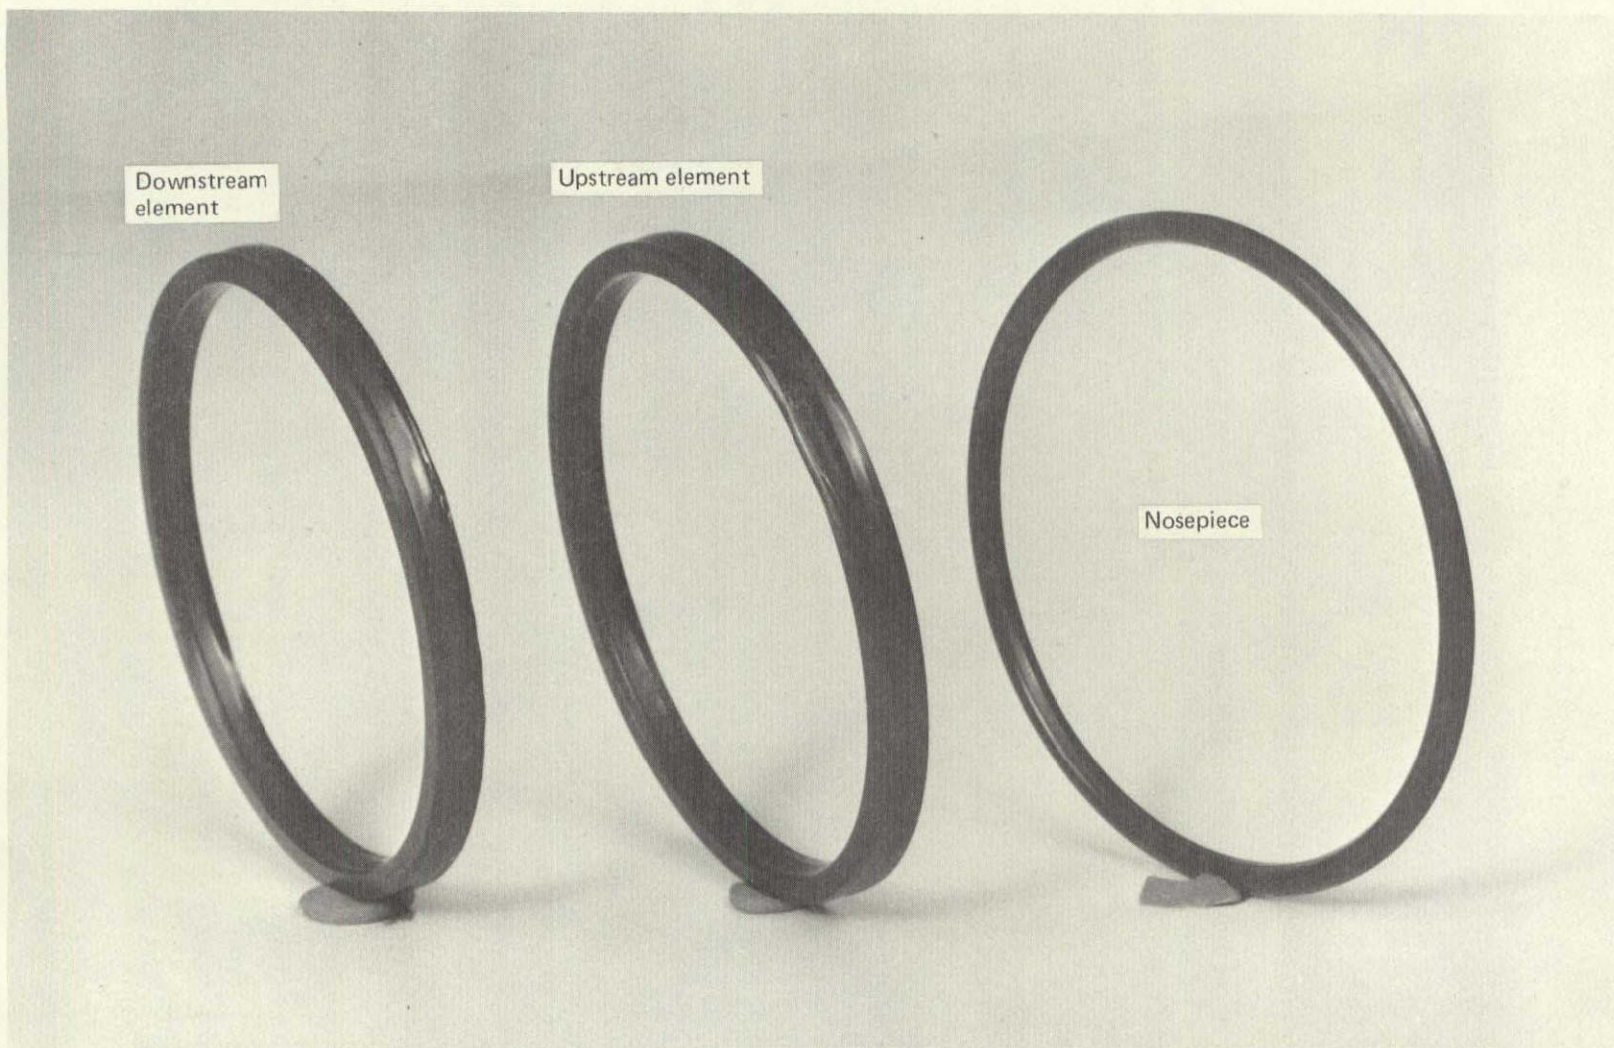
The 40 000 cycles at 311 K (100° F) with 31.030-MPa (4500-psi) peak pressure were successfully completed. Temperature was elevated to 408 K (275° F). With 830 cycles completed of the scheduled 115 000, the K-sections structurally failed. There was no evidence of leakage until seal failure at 40 830 cycles. Figures 8, 9, and 10 show the major fracture points in the upstream and downstream elements respectively.

Upstream element fracture was very similar to the upstream element failure under 17.359 MPa (2500 psi) static pressurization. The cracking in the downstream element was a secondary failure resulting from the upstream element failure. The similarity of failures in impulse testing showed evidence of inadequate natural properties for a seal of the K-section geometry under a loading pressure of 31.030 MPa (4500 psi).

Figure 8.—Impulse Test Seal, Failure at 31.030 MPa (4500 psi)—40 000 Cycles at 311 K (100° F) + 830 Cycles at 408 K (275° F)

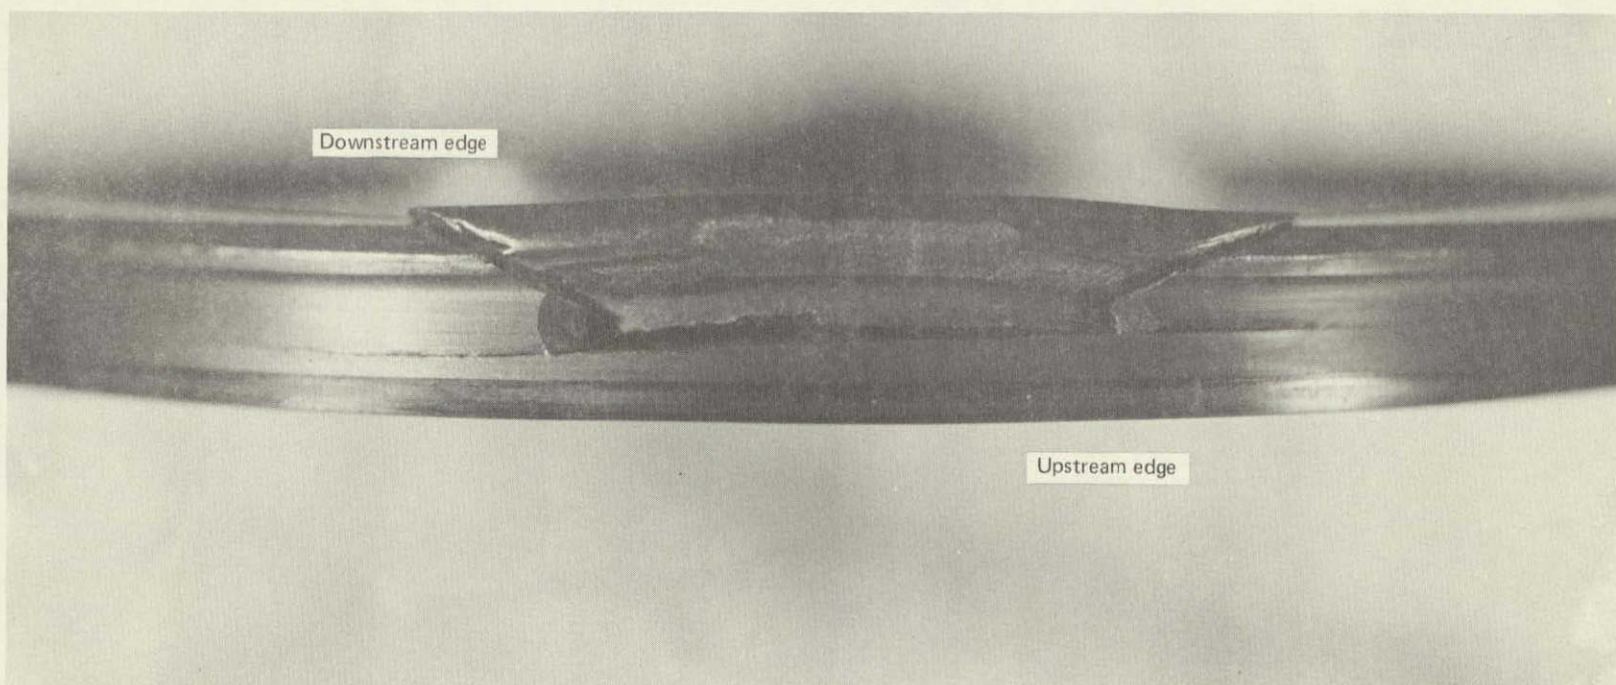
*Figure 9.—Impulse Test Seal, Failure at 31.030 MPa (4500 psi)—Upstream Element, Major Fracture*

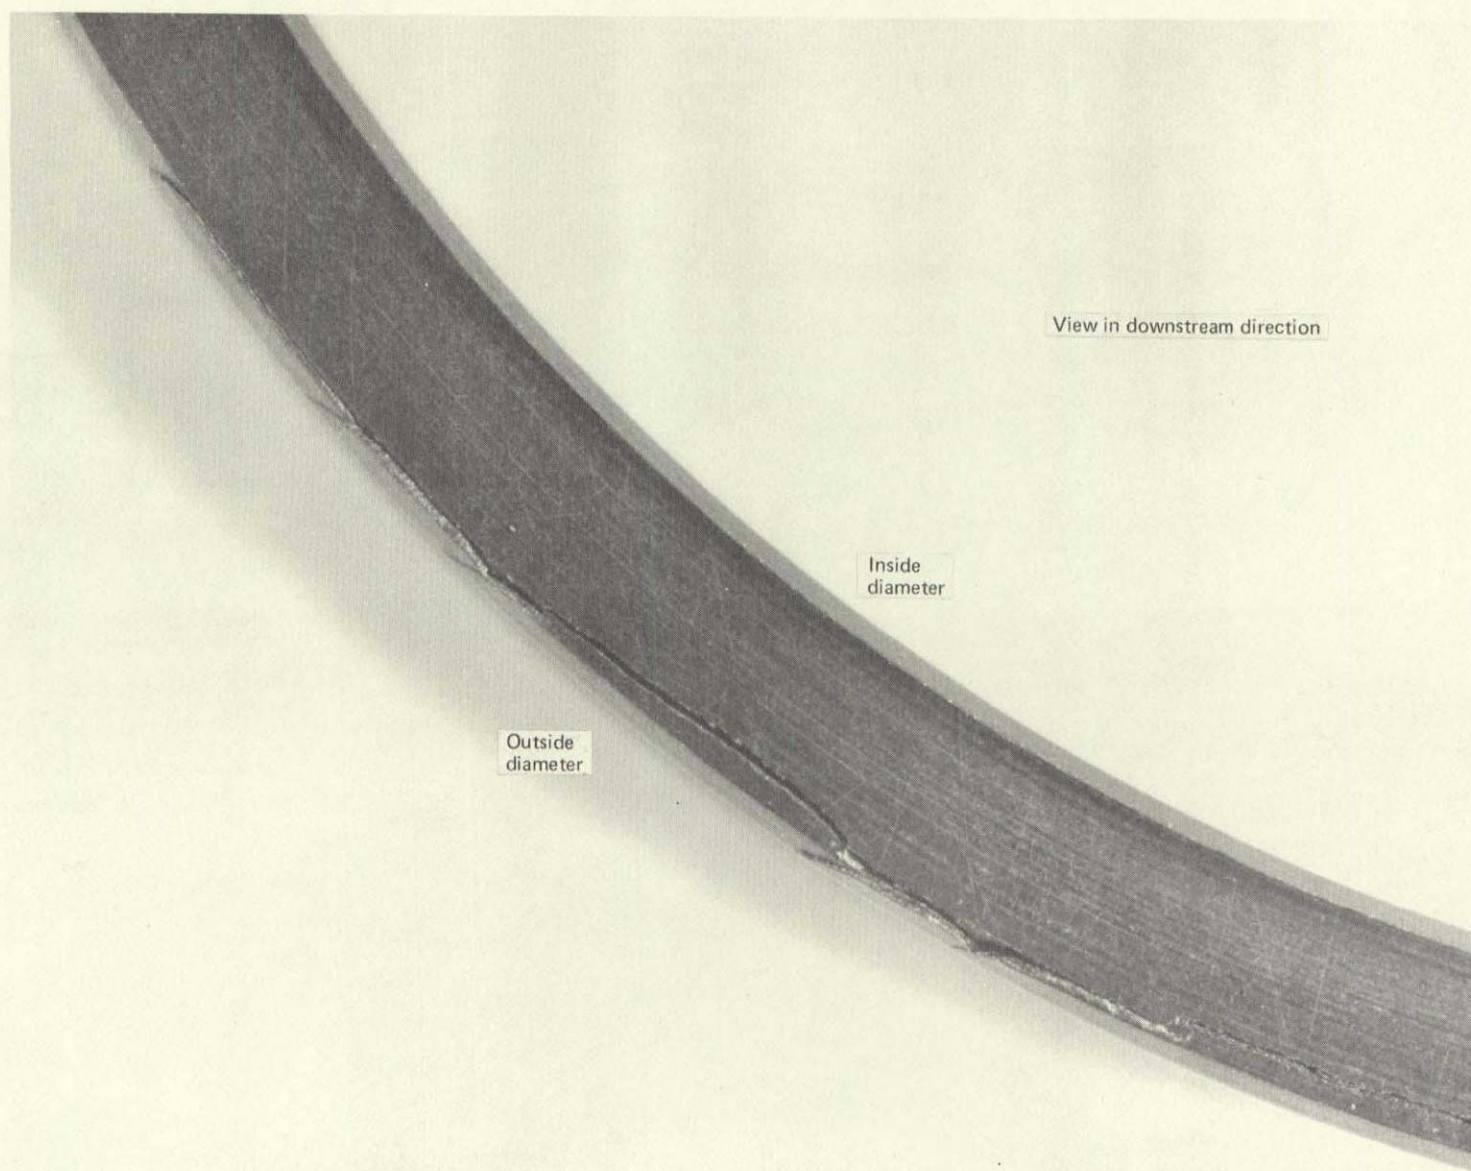
Figure 10.—Impulse Test Seal, Failure at 31.030 MPa (4500 psi)—Downstream Element, Major Fracture

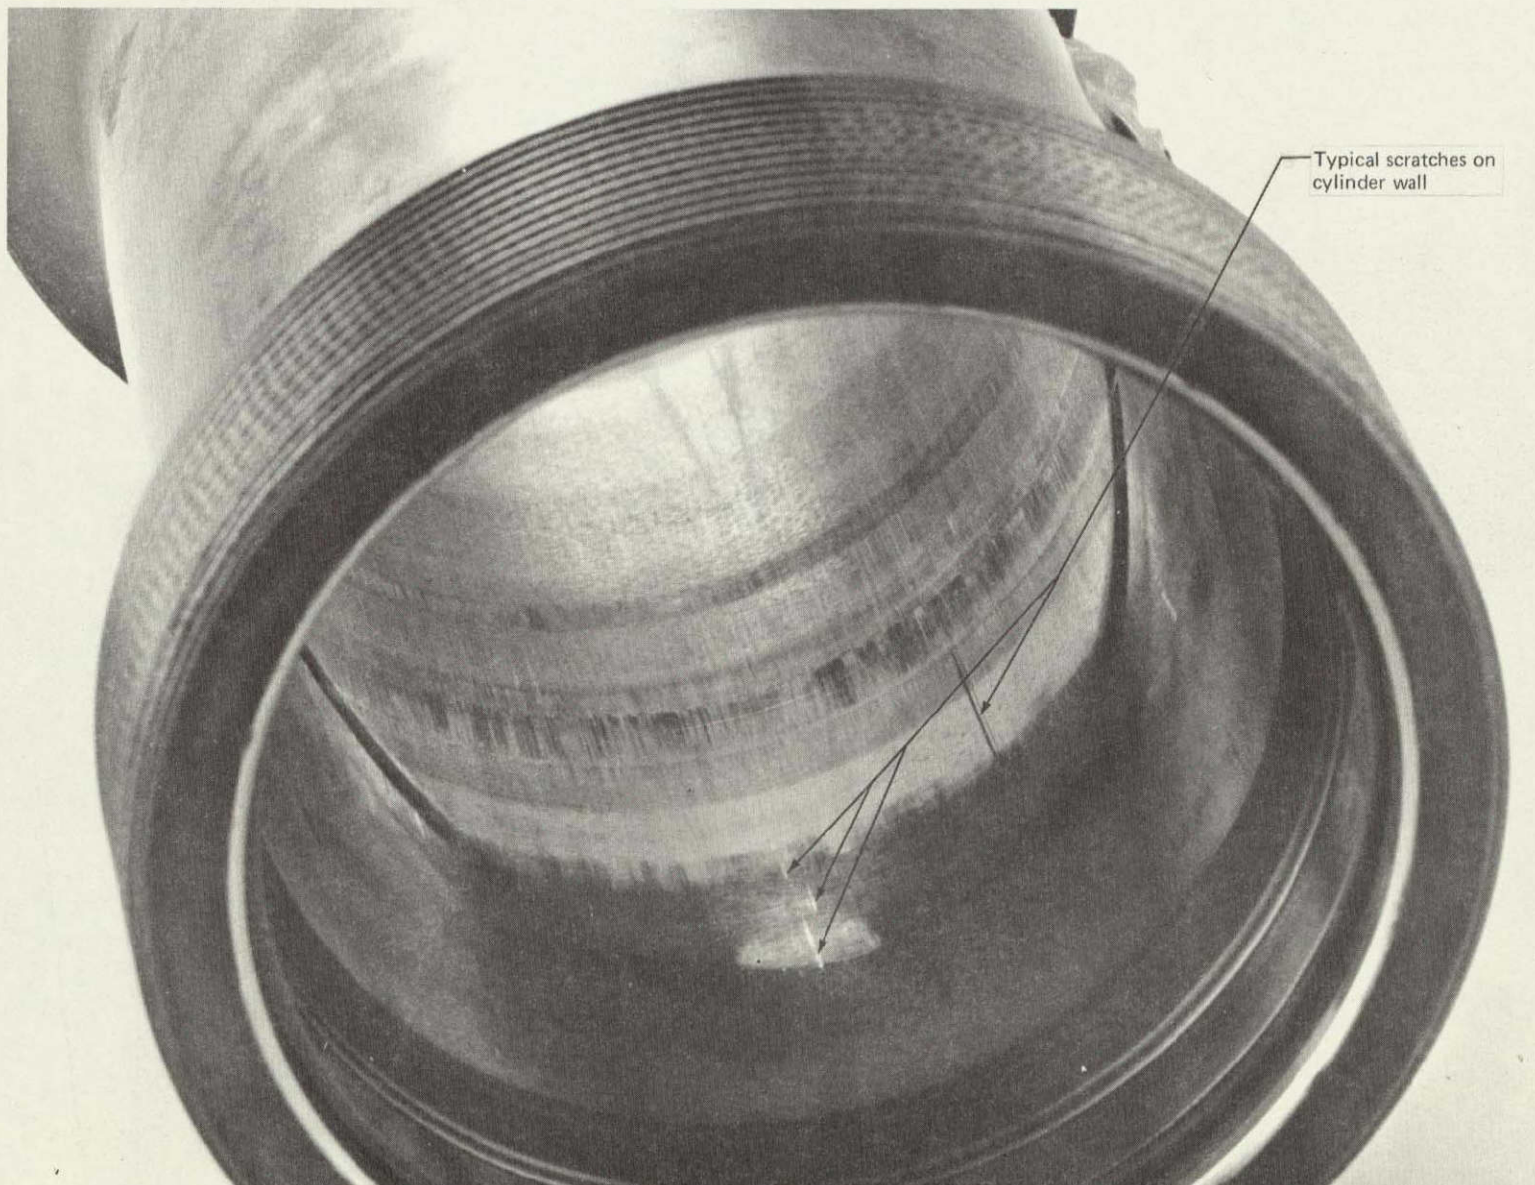
The system was operated for 65 869 cycles with 64 589 of these at 450 K (350° F). Maximum leakage was 0.0004 cc/min. At the time of completion of the above cycles, a noticeable drop in actuator stroking distance, and head/rod end pressures, indicated that some internal leakage was occurring. Inspection of both balance tube and piston seal rings of the endurance actuator (fig. 11) showed that during conditions of steady leakage the piston seal could maintain only 7.584 MPa (1100 psi) differential and the balance tube seal could maintain a differential of only 2.068 MPa (300 psi). The piston ring was intact and showed no abnormal wear. The cylinder showed longitudinal scratches that could account for the excessive leakage of the piston seal (see fig. 12).

An abnormal wear pattern was indicated on the balance tube sealing ring identified by alternating polished and dark areas across the seal. These wear areas are believed to account for the excessive leakage.

Figure 12.—Endurance Actuator Cylinder After Test

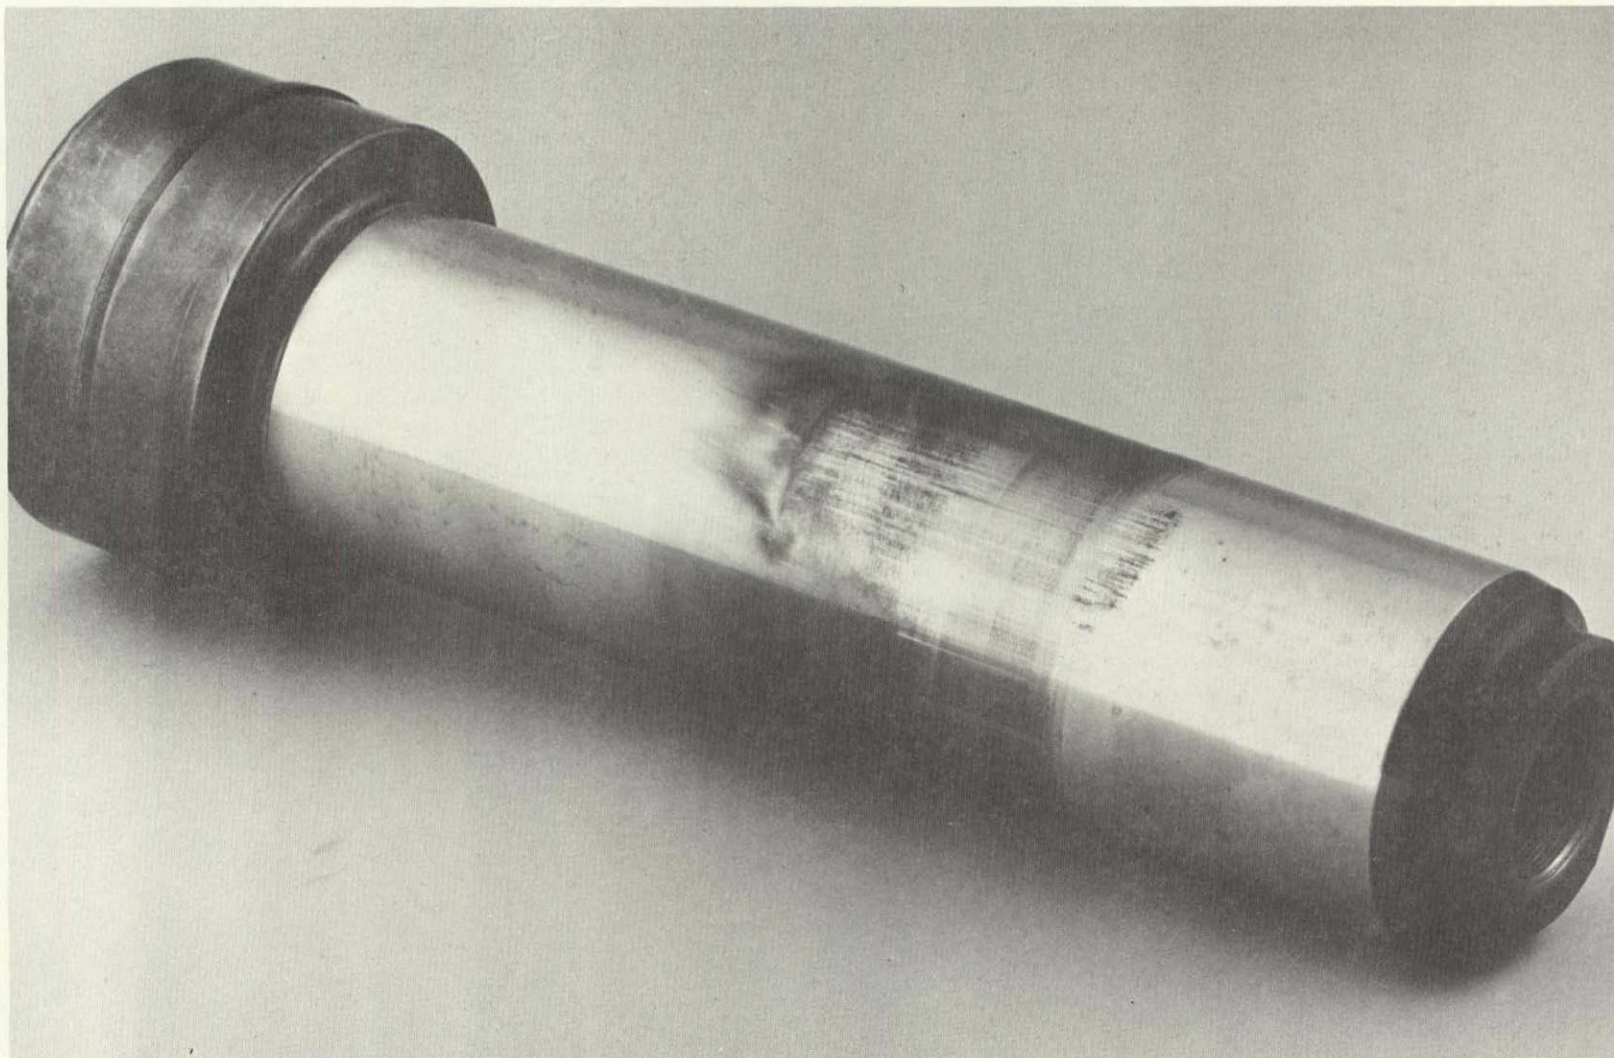
*Figure 13.—Actuator Rod After Endurance Test*

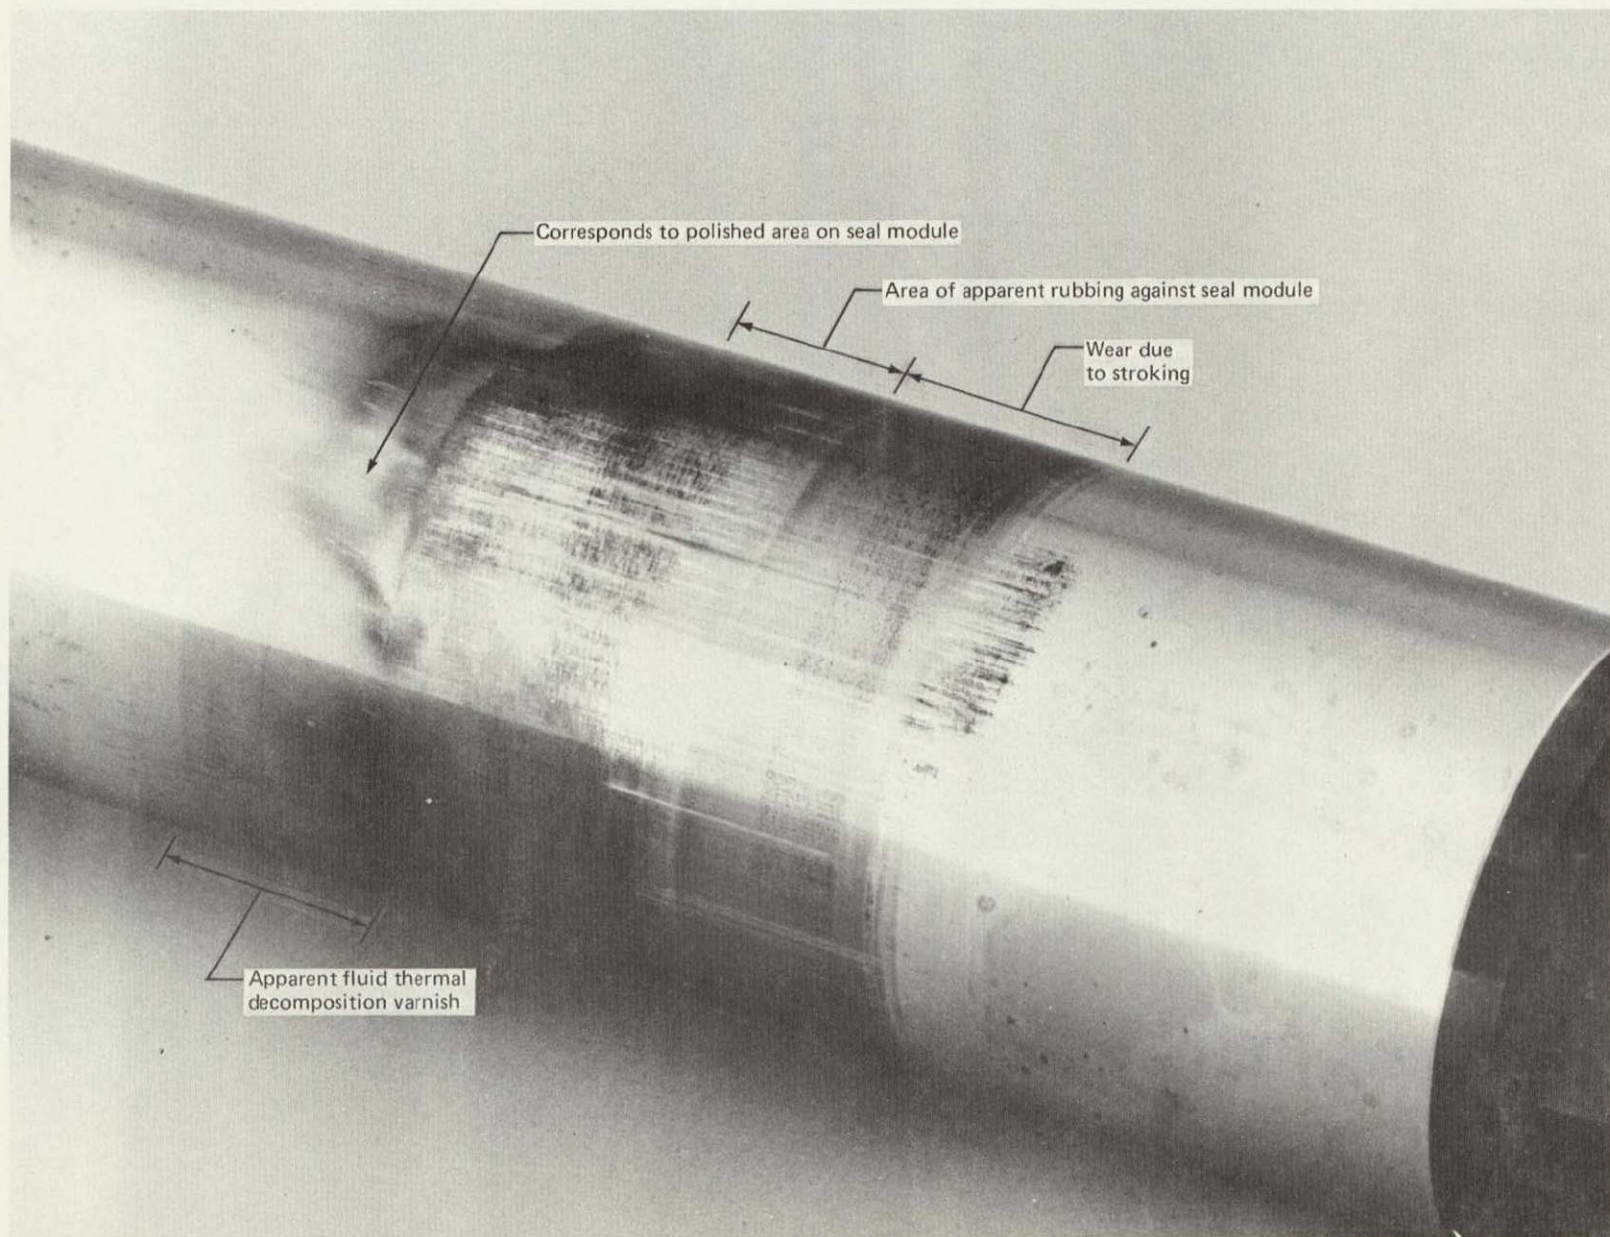
The rod showed an approximate 2.54-cm (1-in.) wear pattern where the test seal made contact. This area was blackish grey in color, indicating considerable wear of the test seal. A bluish-purple band was present upstream of the wear area, indicating localized heating in this area (see figs. 13 and 14). (A similar wear pattern was noted on the test seal module bearing surfaces where the rod made contact—see fig. 15.) Upstream of the purple band on the rod was a yellowish-brown area, which appeared to be like tarnish build-up from thermal decomposition of the fluid.

Figure 14.—Seal Contact Area on Rod After Endurance Test

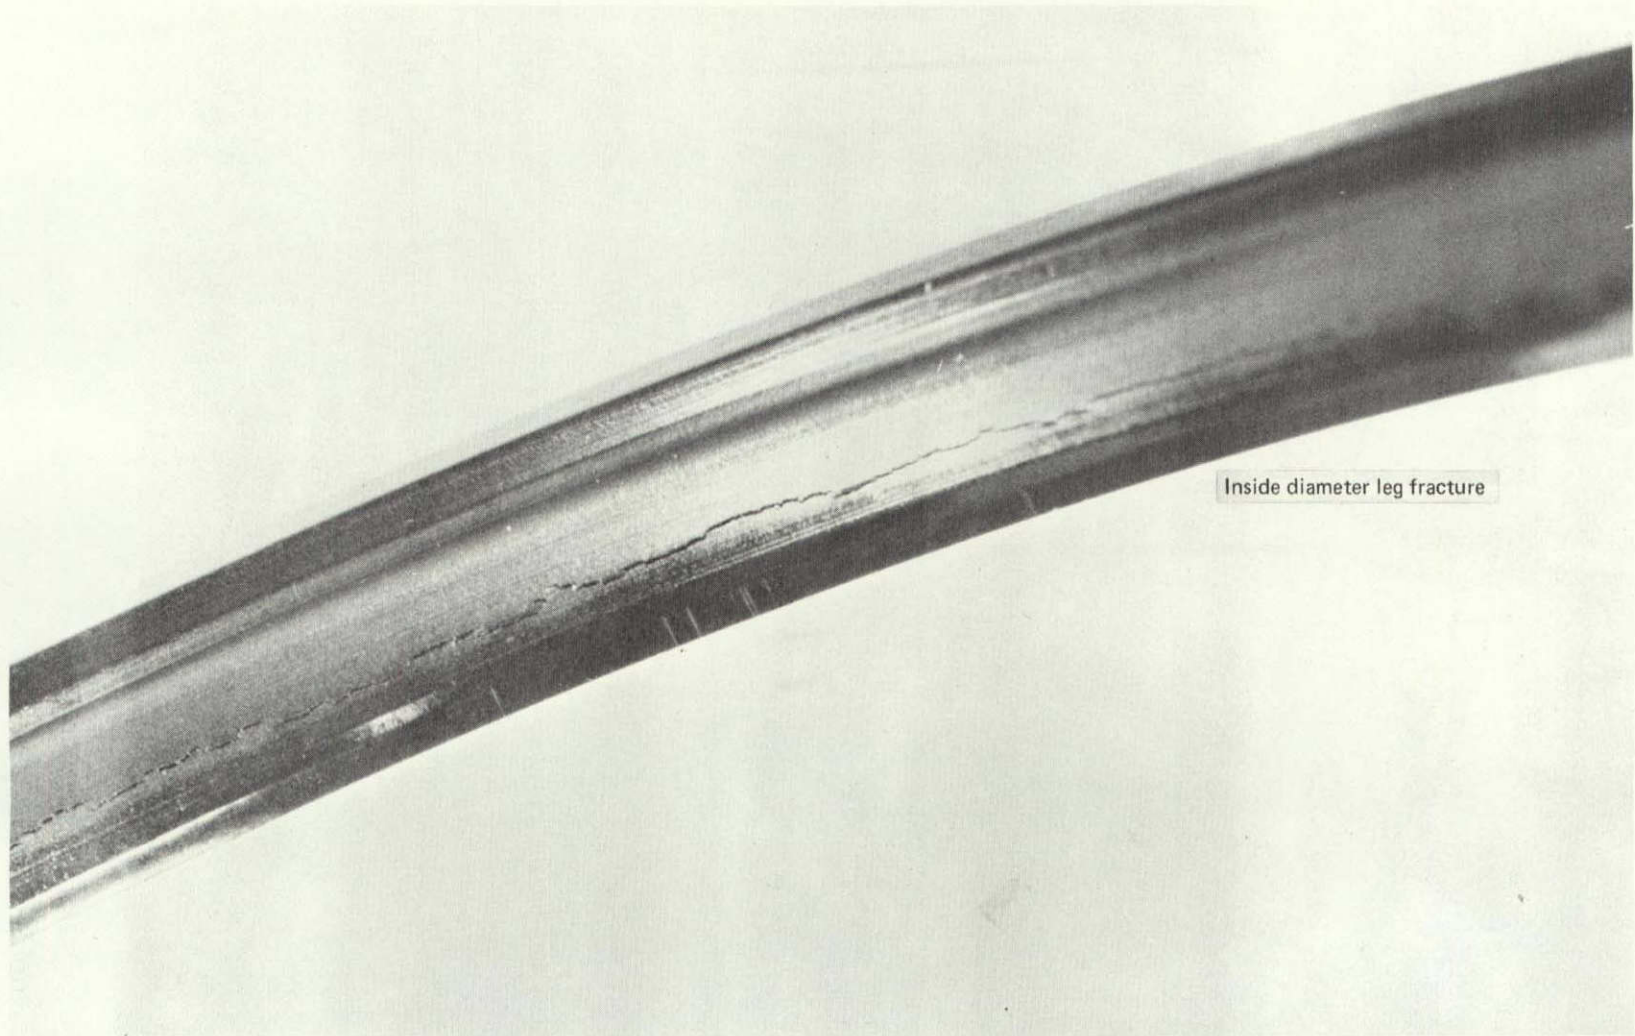
- Upstream element (fig. 17)
  - The od leg was slightly polished on the sealing surface.
  - The id leg was highly polished on the sealing surface, this extending farther back on the leg than the machined sealing flat. The id leg was cracked 160° of the circumference, but the crack did not sever the leg.
- Downstream element (figs. 18 and 19)
  - The od leg had a crack 170° of circumference that did not sever the leg. A second crack in the support block section of the K geometry was 10° in seal circumference and did penetrate through the cross section (see fig. 18).
  - The id leg was cracked approximately 180° of the circumference, and the sealing lip was chipped and worn to a very thin cross section (fig. 19).

*Figure 17.—Upstream Element Fracture, Endurance Test Seal*

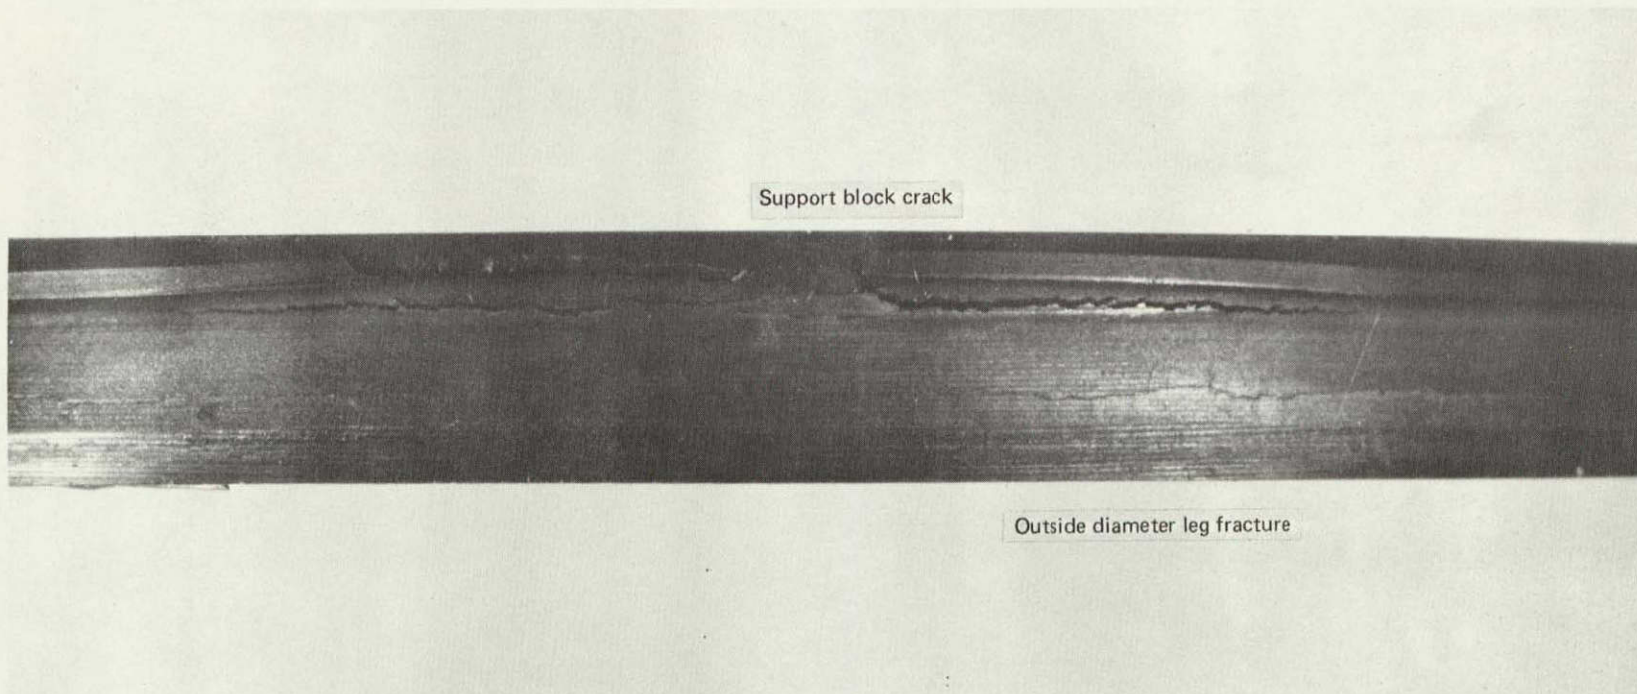
*Figure 18.—Downstream Element Fracture, Endurance Test Seal*
